# *Central Place Design Guidelines*

## **Central Place Historic District**

*Kirkwood Landmarks Commission*

**Date: June 2004**

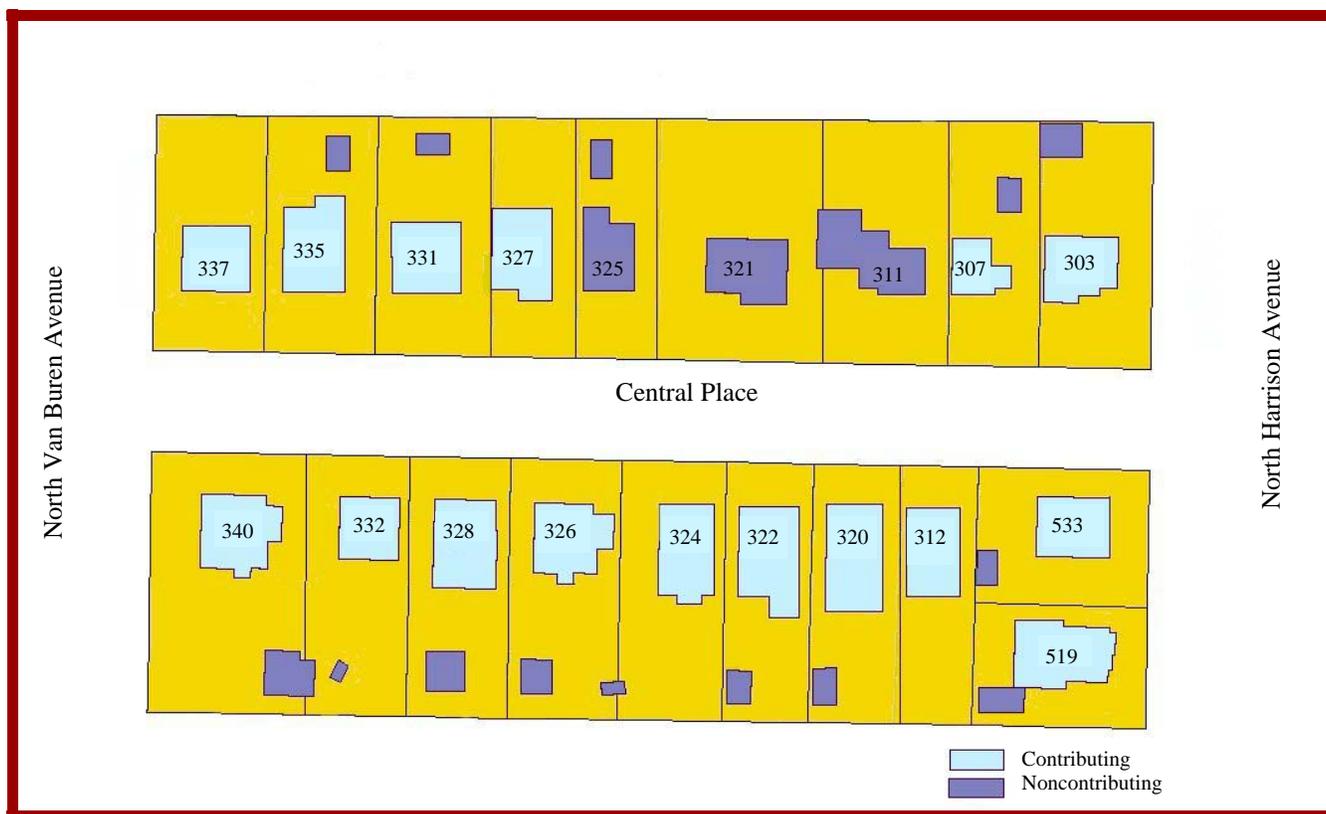
## Central Place Historic District Map

The Central Place Historic District is located just north of the 1853 original square mile boundaries of Kirkwood. It consists of 17 homes in the 300 block of Central Place and two homes facing N. Harrison Avenue. Bungalow style homes predominate on the block and all but three have maintained their original character from the 1920s. The City designated the area a local historic district in 1998.

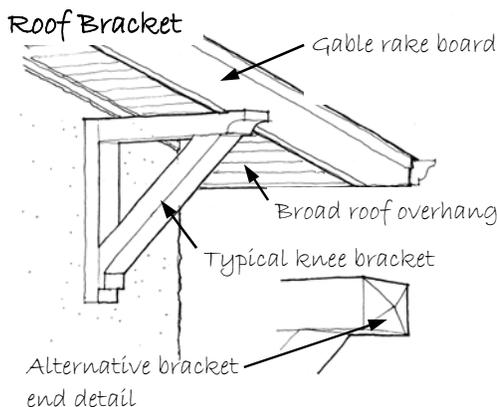
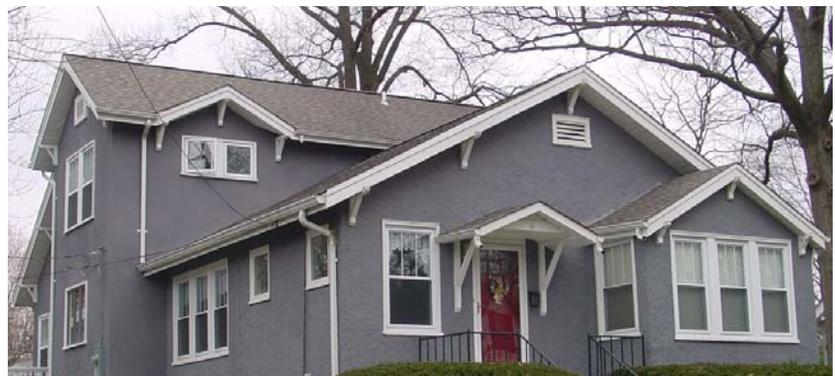
## House Types

The roof is a distinguishing feature of a historic structure, helping to define its architectural character and the buildings overall form. The interplay of roof forms, materials and details helps give the historic district its unique character. The most common roof form in the district is gable, but complex roofs mixing gable, hip, gambrel and other roof shapes are also found. Roofs may feature bracketed eaves, open rafters, rafter tails and generous overhangs. The most widely used roofing material is composition shingles of asphalt in a variety of patterns.

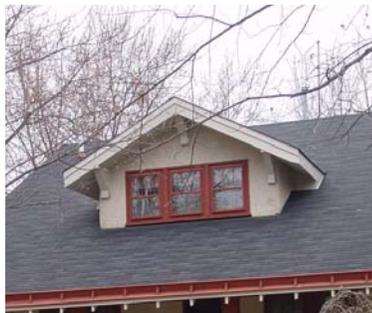
Due to the low building height typical of Bungalow style residences, dormers satisfied the functional need to increase ceiling clearance at upper floors and to admit natural light through dormer windows. Shed, gable and hip dormer roofs are most common.

- Adding dormers that match existing roof overhangs, slopes, prevailing roof type and bracket details (if applicable).
- Adding dormers at least a few feet away from existing roof edges to preserve visual clarity of the main roof form.

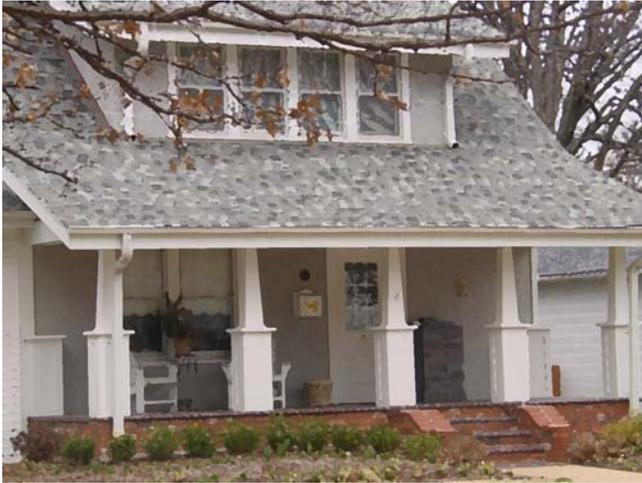
## Porches and Entryways

Porches are one of the most distinguishing features of the Craftsman Bungalow style. In addition to presenting a welcoming face to the street, the porch was seen as an outdoor room where the family could be closer to nature and visit with their neighbors. Spatially defined by low walls or balustrades and sheltered by extending the slope of the roof, most porches are full or half width. Since main floors are raised above grade a few feet, porches are accessed by a series of steps from the front walk which helps to emphasize the entry.

The roof structure is supported by prominent, stout wood or stucco columns which may sit on solid piers. Some columns have slightly slanted vertical surfaces and many appear fatter than necessary; yet, this characteristic is a hallmark of the style.

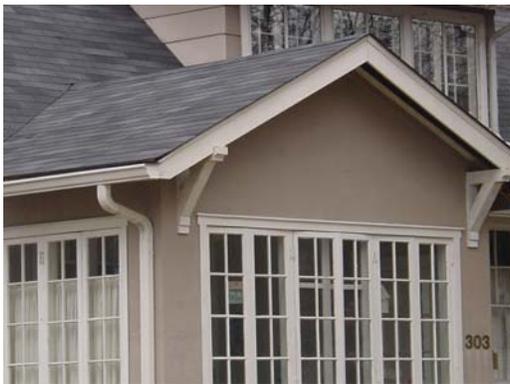
## Doors & Windows

Front doors were considered to be an important feature of the entryway and were thoughtfully conceived and constructed to demonstrate the skill of the carpenter craftsmen. Wood stile and rail frames with slightly recessed flat wood panels and some glass is most common.

Windows are mostly double hung with glass light sash patterns of three over one, six over one and some six over six. In several cases, sunrooms and enclosed porches have casement style windows with Craftsman style muntin patterns.
