Central Place Design Guidelines

Central Place Historic District

Kirkwood Landmarks Commission

Date: June 2004

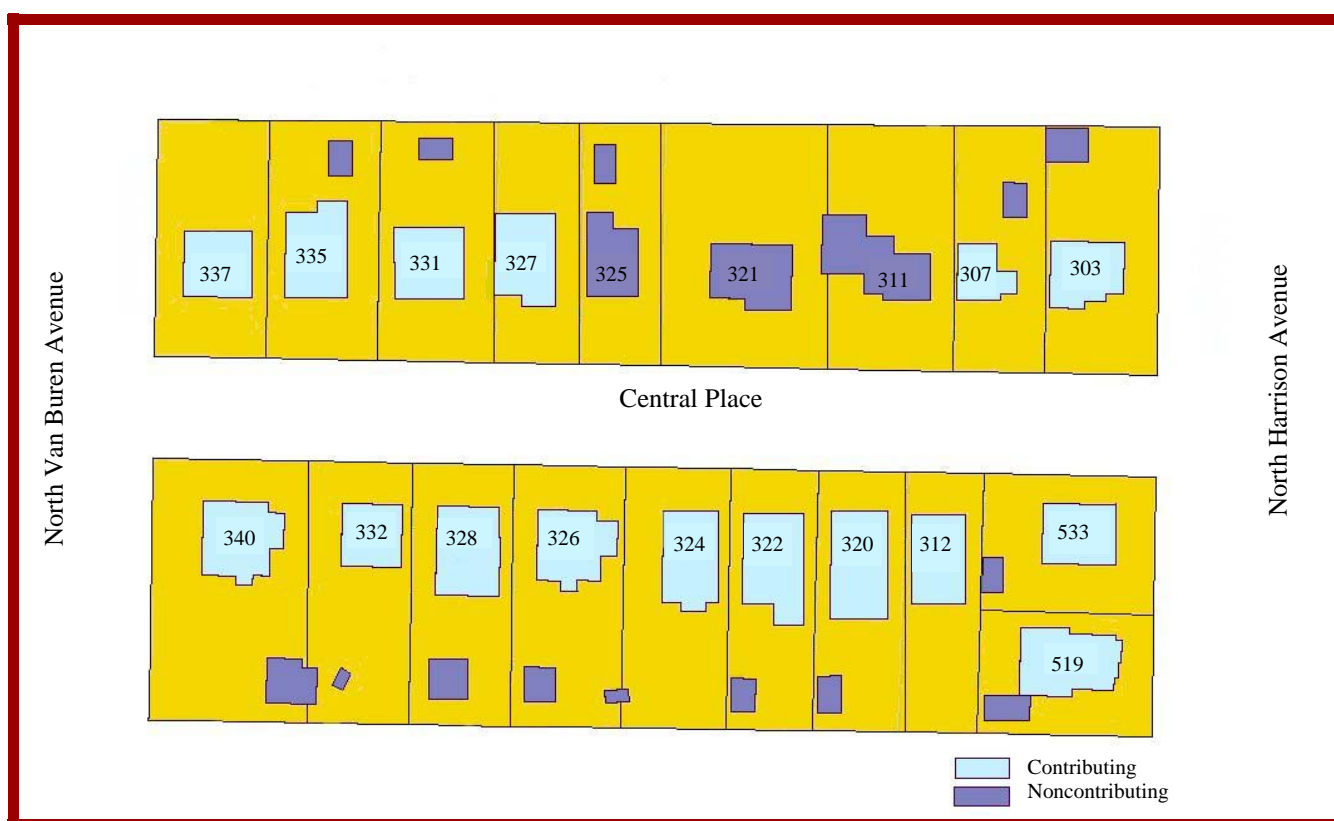
Central Place Historic District Map

The Central Place Historic District is located just north of the 1853 original square mile boundaries of Kirkwood. It consists of 17 homes in the 300 block of Central Place and two homes facing N. Harrison Avenue. Bungalow style homes predominate on the block and all but three have maintained their original character from the 1920s. The City designated the area a local historic district in 1998.

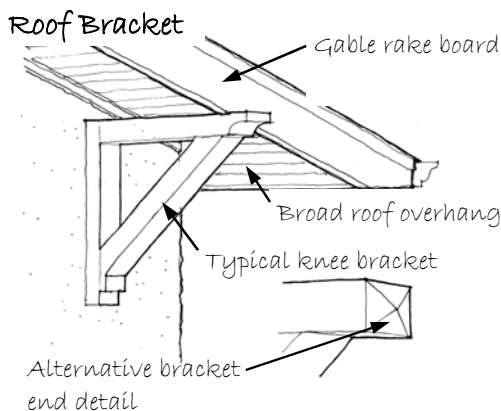
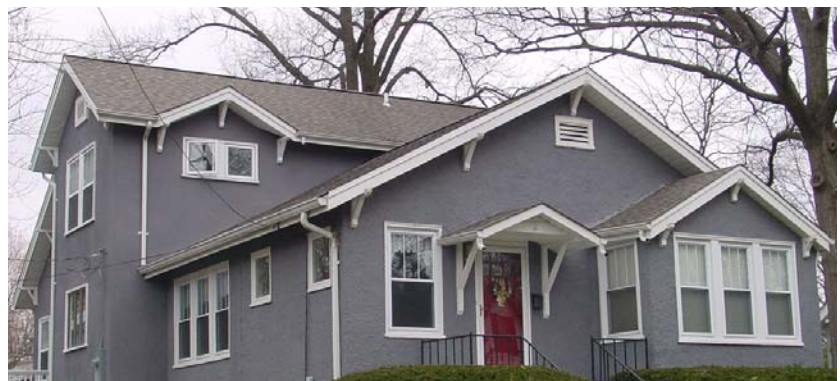
Gambrel roof - shed dormer

Gable roof - front gable porch

Double slope side gable - gable dormer

Side gable - hip dormer

The roof is a distinguishing feature of a historic structure, helping to define its architectural character and the buildings overall form. The interplay of roof forms, materials and details helps give the historic district its unique character. The most common roof form in the district is gable, but complex roofs mixing gable, hip, gambrel and other roof shapes are also found. Roofs may feature bracketed eaves, open rafters, rafter tails and generous overhangs. The most widely used roofing material is composition shingles of asphalt in a variety of patterns.

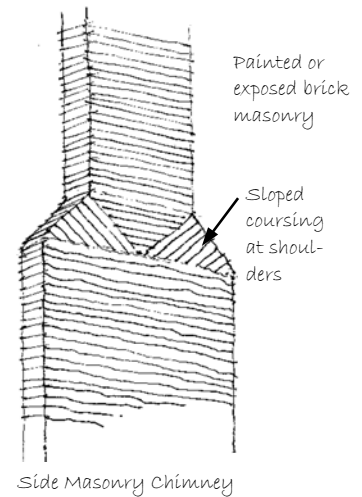
Many of the homes in the Central Place Historic District have painted brick chimneys as a significant architectural feature. The common foundation material used was locally available limestone or brick. Proper maintenance of chimneys, foundations and other masonry/stone surfaces may include re-laying any loose brick or stone, careful re-pointing deteriorated mortar joints and proper replacement of metal flashing where the chimney meets the roof or wall. Techniques such as sand blasting and high pressure washing erodes the brick exterior causing moisture to get inside, and water proof coatings such as a silicone-based sealant will actually trap moisture inside. These techniques should be avoided.

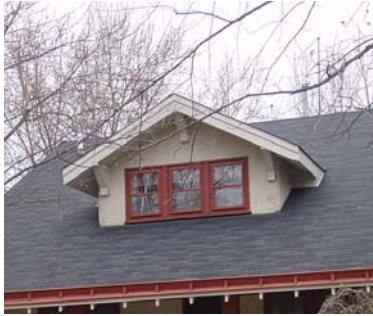
Dormers

Due to the low building height typical of Bungalow style residences, dormers satisfied the functional need to increase ceiling clearance at upper floors and to admit natural light through dormer windows. Shed, gable and hip dormer roofs are most common.

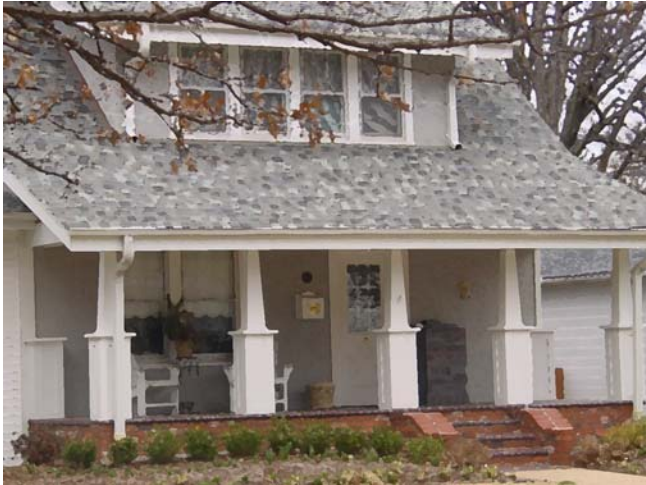
Porches are one of the most distinguishing features of the Craftsman Bungalow style. In addition to presenting a welcoming face to the street, the porch was seen as an outdoor room where the family could be closer to nature and visit with their neighbors. Spatially defined by low walls or balustrades and sheltered by extending the slope of the roof, most porches are full or half width. Since main floors are raised above grade a few feet, porches are accessed by a series of steps from the front walk which helps to emphasize the entry.

The roof structure is supported by prominent, stout wood or stucco columns which may sit on solid piers. Some columns have slightly slanted vertical surfaces and many appear fatter than necessary; yet, this characteristic is a hallmark of the style.

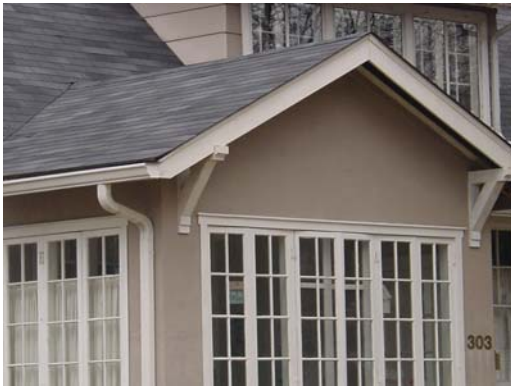
Front doors were considered to be an important feature of the entryway and were thoughtfully conceived and constructed to demonstrate the skill of the carpenter craftsmen. Wood stile and rail frames with slightly recessed flat wood panels and some glass is most common.

Windows are mostly double hung with glass light sash patterns of three over one, six over one and some six over six. In several cases, sunrooms and enclosed porches have casement style windows with Craftsman style muntin patterns.
